Field Report for Airborne Data Collected In Support of US EPA Region 6 Intercontinental Terminals Company LLC Fire 28 March 2019

Data Results Flight 15, 28 March 2019

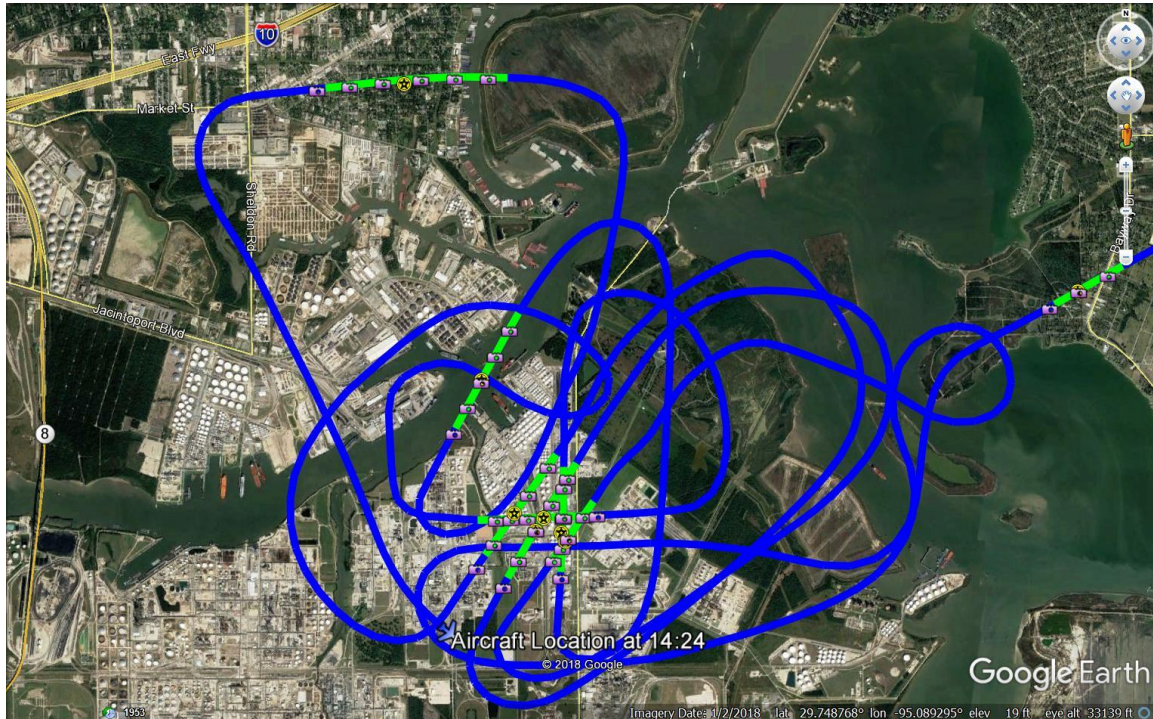
Figure 2: Flight line data for 28 March 2019, Flight 15. The blue lines represent the ASPECT flight path, green lines represent when the Infrared Line Scanner was actively collecting data, and the camera icons represent when a photo was taken.

The order to launch the aircraft was given at 0830 local on 28 March 2019 and the aircraft was airborne at 0840. The initial data collection run over the site was at 0901 (local) and the aircraft made a total of 7 data collection passes. Flight information is summarized in Appendix A and Figure 2.

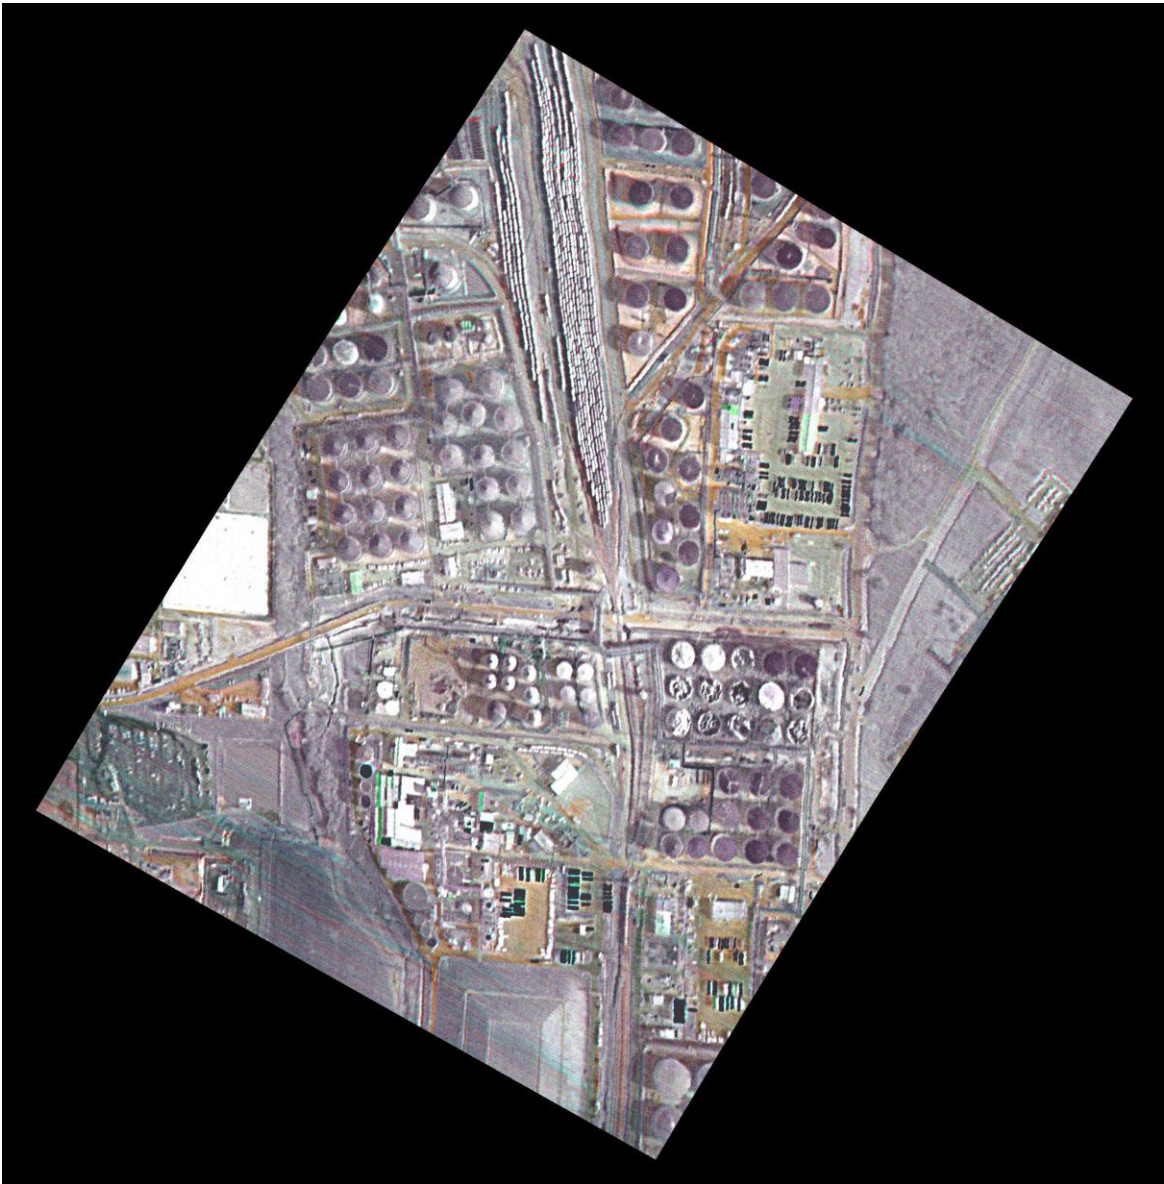
A total of 1 test and 7 data passes were made in the proximity of the impacted tank farm and also in extended areas surrounding the site and infrared line scanner images were generated for each pass. Figure 3 shows a typical 3-band infrared image obtained from data collected for Run 3. IR imagery is showing no change from flight 14 indicating that the tank farm is stable. A thermal image of the tank farm shows no significant difference

Figure 3: IR image of ITC data for 28 March 2019, Flight 15 Run 2

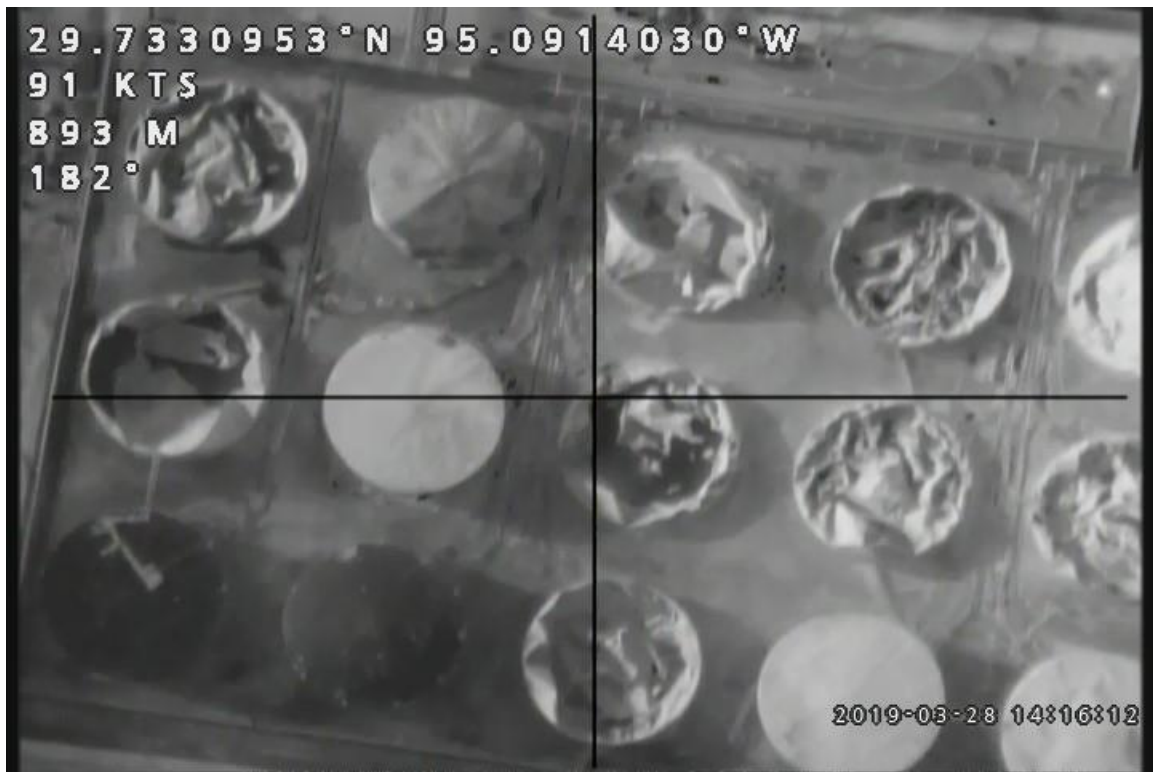
from previous missions again indicating that tank surfaces are at or near ambient temperature (some solar heating is occurring). As with other thermal images, note that the bottom right in the image is the NW due to the image being inverted.

Figure 4: IR Thermal Analysis 28 March 2019, Flight 15, Run 6

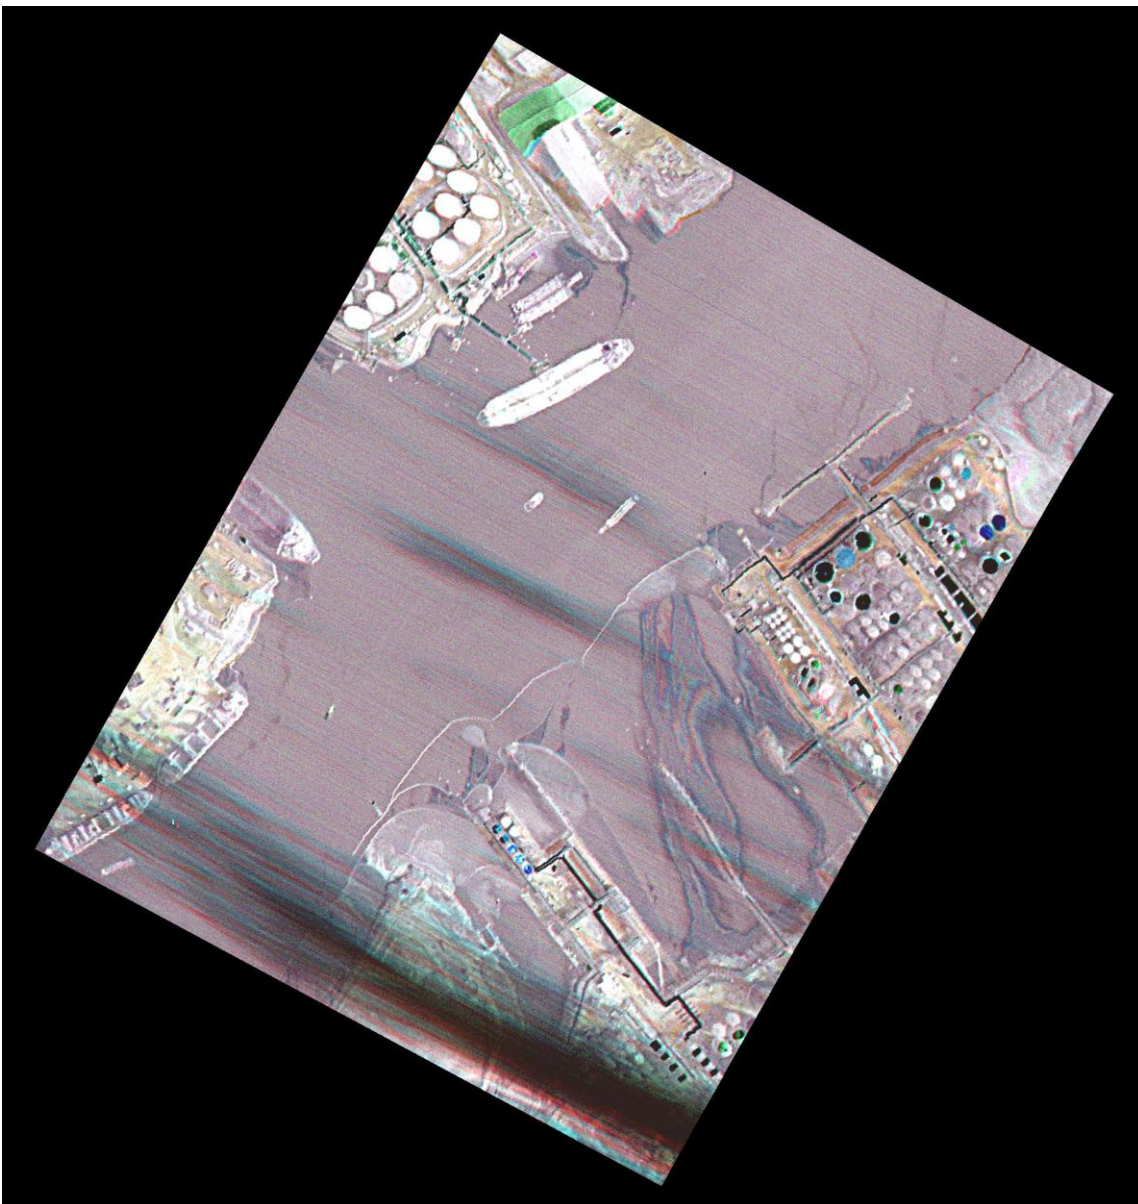
An IR image of the confluence area is given in Figure 5. It should be noted that the banding in the image are low level clouds. As with prior missions, the boom structure and trapped product are evident. Little boom leakage is present in this image.

Figure 5: IR Image of Contained Oil 28 March 2019, Fight 15, Run 7

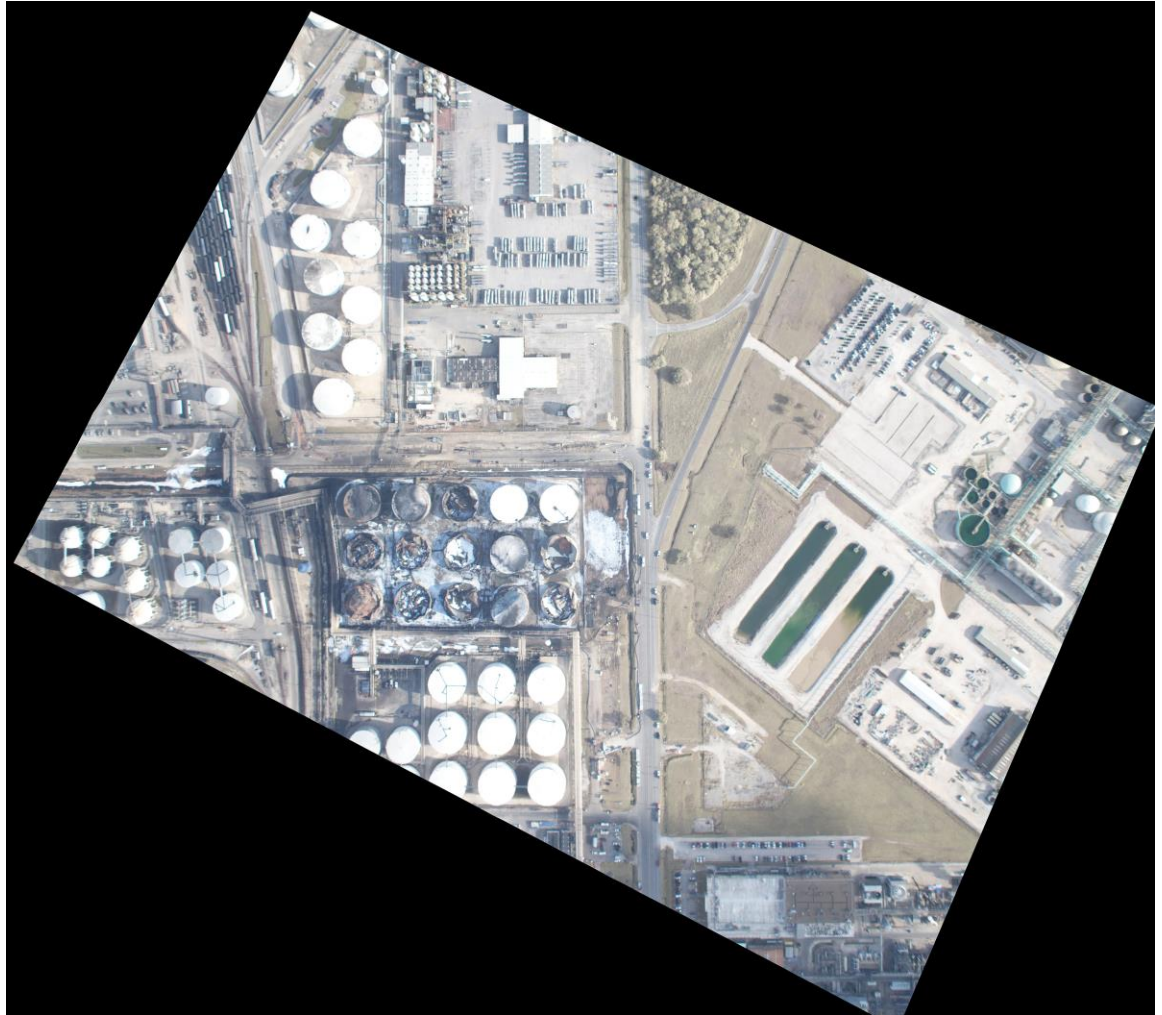
A full set of high resolution aerial digital photography was collected as part of the flight. Figure 6 shows a representative overhead image collected as part of each pass over the tank farm. Visible imagery on Flight 15 was of poorer quality than previous missions due to low level clouds and haze in the area. Analysis of the image shows no noticeable change from prior images, again indicating that the scene is stable. An aerial image of the confluence area is shown in Figure 7. Trapped product appears to be

Figure 6: Aerial Image of the Tank Farm, 28 March 2019, Flight 15

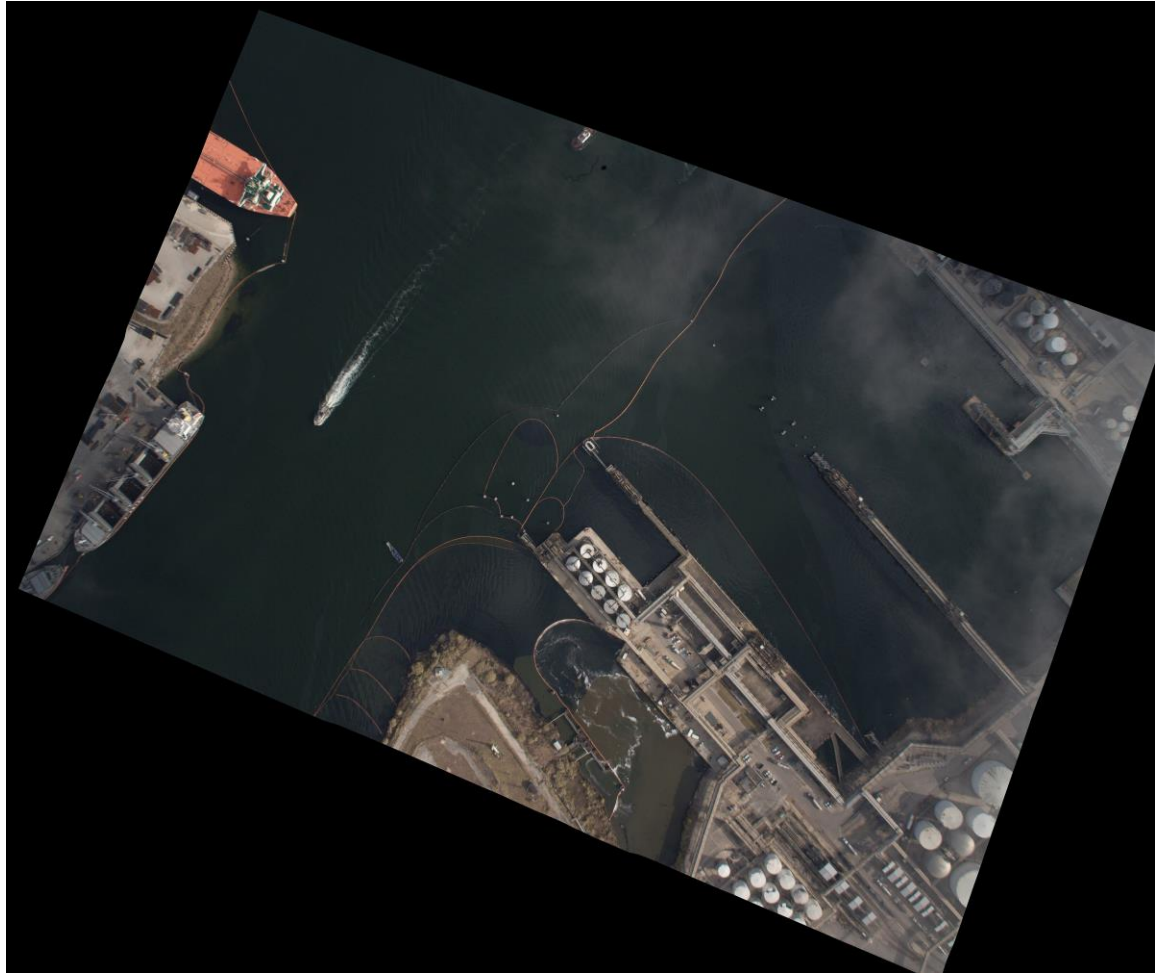
primarily present at the upstream boom and no boom leakage is evident. An oblique of the same area confirms the presence of trapped material in the upstream boom (Figure 8). The white signature present on the overhead and IR is actually boat wakes. Product containment appears to be solid in the oblique.

Figure 7: Aerial Image of the Ship Channel Boom Area, 28 March 2019, Flight 15

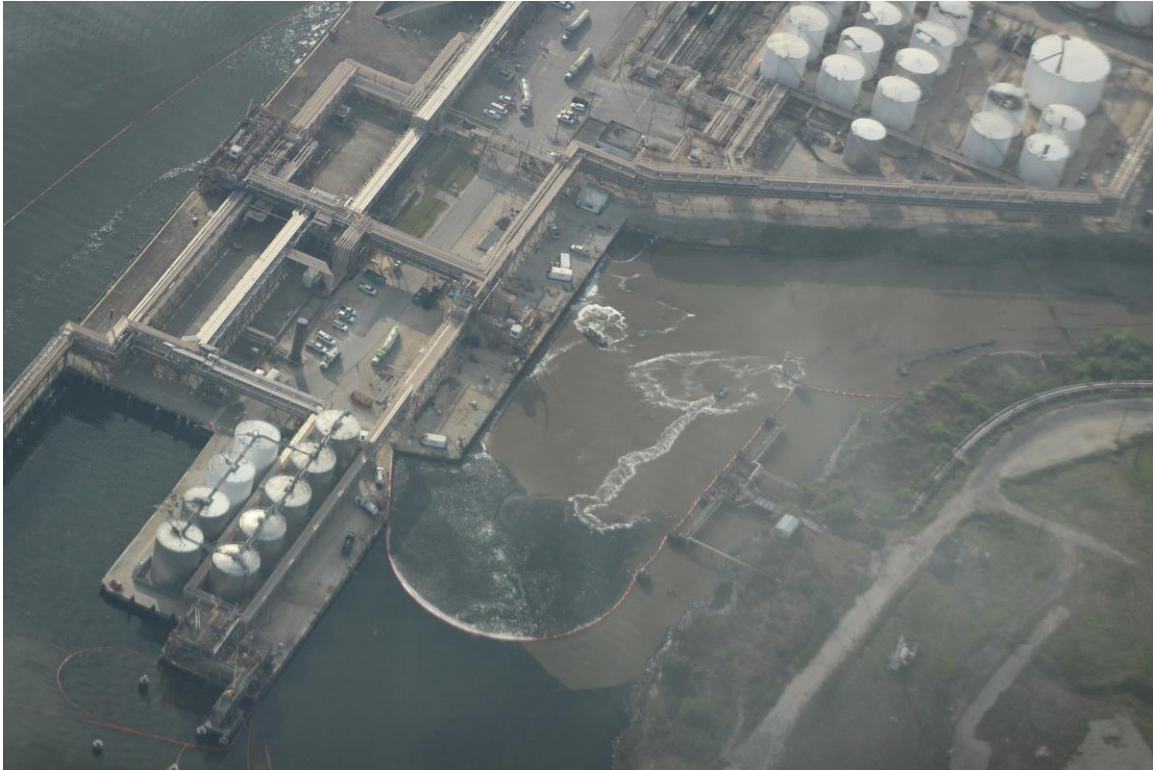
Figure 8: Oblique Image of the Ship Channel Boom Area, 28 March 2019, Flight 15
